Manhole Inspection Summary

Manhole # S57C__002MH

Insp Date: **6/25/08 11:35 AM**

Location Address: **4020 e baltimore st**

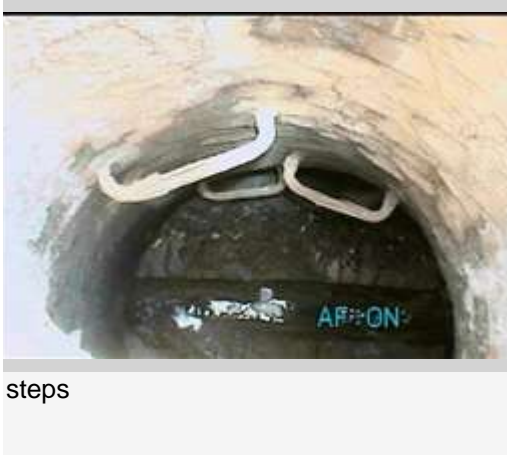
Defect 2

Steps Count: **3** Missing: **0** ☒ **Corroded**

steps

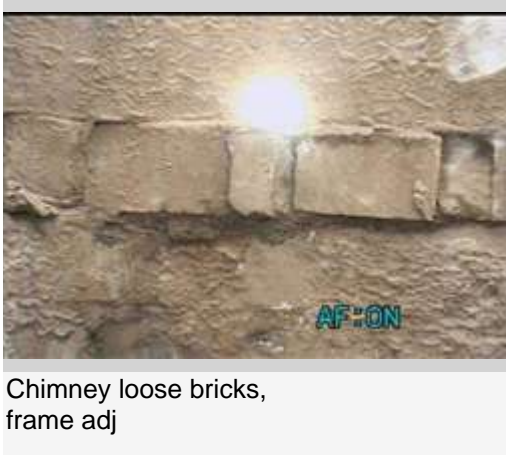
Defect 1

Condition: ☐ Sound ☐ Cracked ☐ Root Intrusion ☒ **Loose Brick** ☐ Deteriorated

Chimney loose bricks,
frame adj

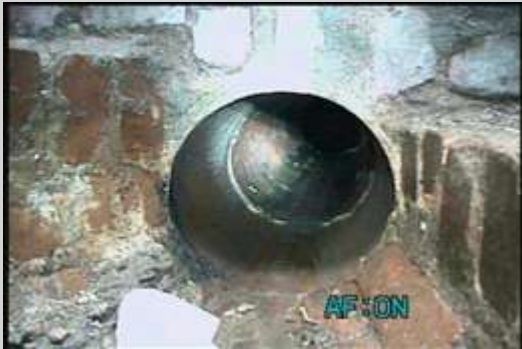
12 O'Clock Outflow

8 in. Circular Gravity Sewer
Pipe Out @ 12 O'Clock

Invert Depth: **8.48** (ft.) Flow Characteristics: **Fast**

Deposits: ☒ None ☐ Mud ☐ Sludge ☐ **Debris** ☐ Grease

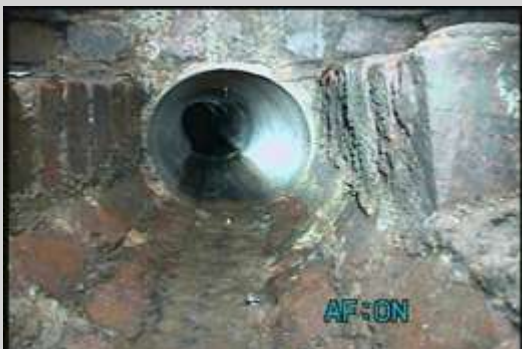
6 O'Clock Inflow

8 in. Circular Gravity Sewer
Pipe In @ 6 O'Clock

Invert Depth: **8.38** (ft.) Flow Characteristics: **Fast**

Deposits: ☒ None ☐ Mud ☐ Sludge ☐ **Debris** ☐ Grease

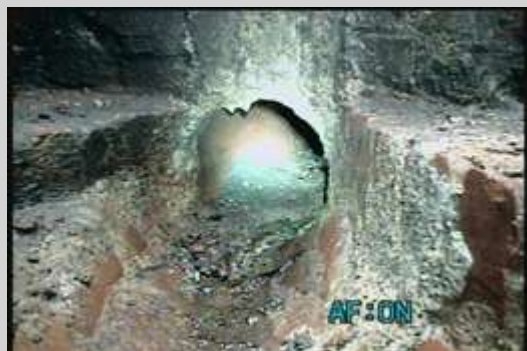
9 O'Clock Inflow

8 in. Circular Gravity Sewer
Pipe In @ 9 O'Clock

Deposits: ☐ None ☐ Mud ☐ Sludge ☒ **Debris** ☐ Grease

Silt Depth: 3 (in.) Deposits Extent: **Light**
